**Werkstatt-Tipps Lenkhydraulik:
Spülen von Lenksystemen**

Workshop Tips Steering Hydraulics: Flushing Steering Systems

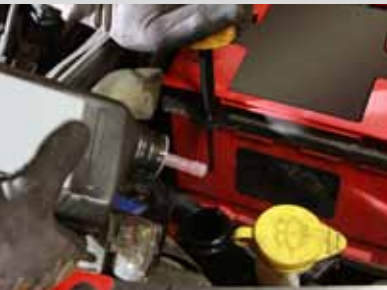
1

Demontieren Sie das defekte Lenkgetriebe nach Herstellervorgaben.

Füllen Sie neues Hydrauliköl in den Vorratsbehälter und lassen Sie es durch die Rücklaufleitung in einen Auffangbehälter laufen.

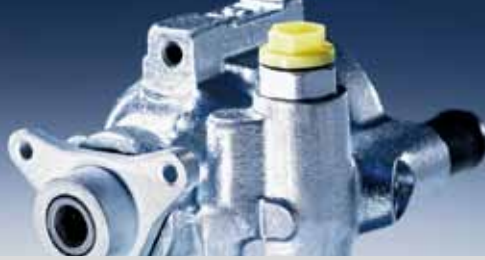
3

Anschließend dichten Sie die Rücklaufleitung vorläufig ab.

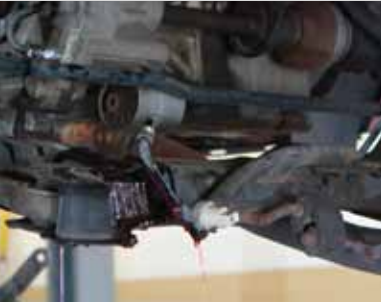
- 4 Füllen Sie einen Auffangbehälter mit Hydraulikflüssigkeit und führen Sie die Druckleitung in die Flüssigkeit.

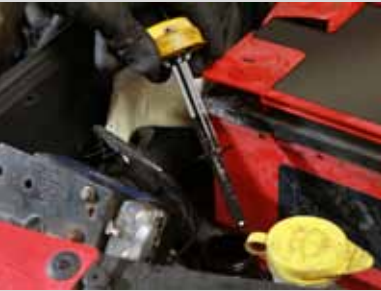
- 5 Lassen Sie den Motor durchdrehen (nicht starten!) und füllen Sie stetig Hydraulikflüssigkeit nach.
Sobald sauberes, klares Öl in den Behälter läuft, mindestens 2 bis 3 weitere Liter Öl durch die Anlage laufen lassen, bis das alte Öl und Verschmutzungen vollständig beseitigt sind.

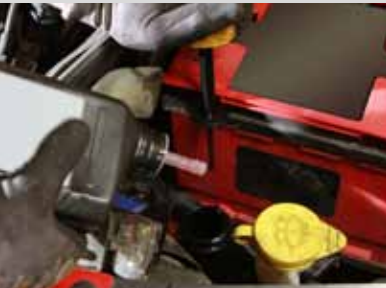
1

Disassemble the defective steering rack in accordance with manufacturer's instructions.

Fill the storage tank up with fresh hydraulic fluid and allow it to flow through the return pipe and into a collection container.

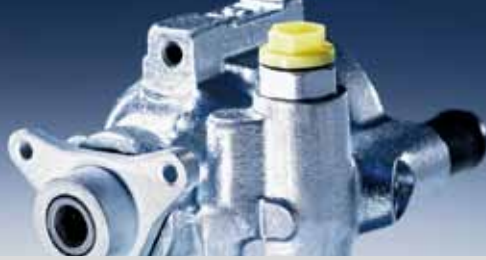
3

Afterwards, temporarily seal the return pipe.

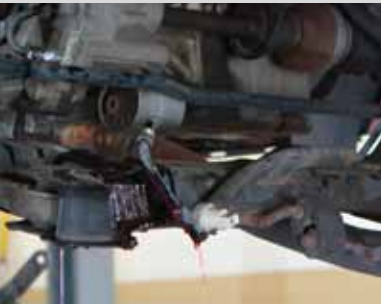
- 4 Fill up a collection container with hydraulic fluid and guide the pressure hose into the fluid.

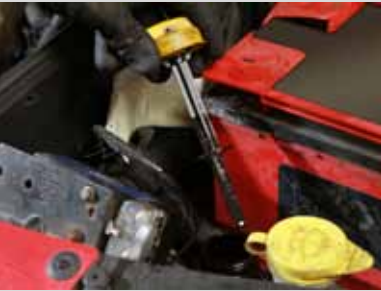
5

Rev up the engine (without starting it!) and keep filling up with hydraulic fluid.

Provided that clean, clear fluid runs into the container, pour another 2 to 3 litres of fluid into the system until old fluid and dirt has been completely removed.
